ELEMENT FAILURE CHECK OUT 2100/3100/4100/4200/5100

CHECK OUT

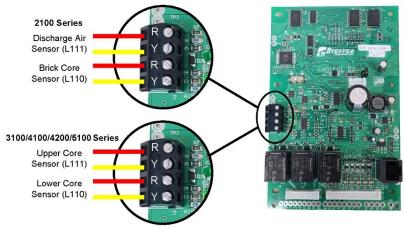
- Core temperature sensor(s) are k-type thermocouples and are polarity sensitive. Verify the core temperature sensor(s) are connected as shown below. The red wire goes to R and the yellow wire goes to Y.
- Verify there is no insulation caught in the connections.
- Do a pull test on the wires. A loose connection will cause the temperature readings to be inaccurate and to fluctuate.

NOTE: 4120, 4210 and 5120 only have one core sensor, connected to the lower two terminals.
