# Error 20 - 4200 Serenity Series

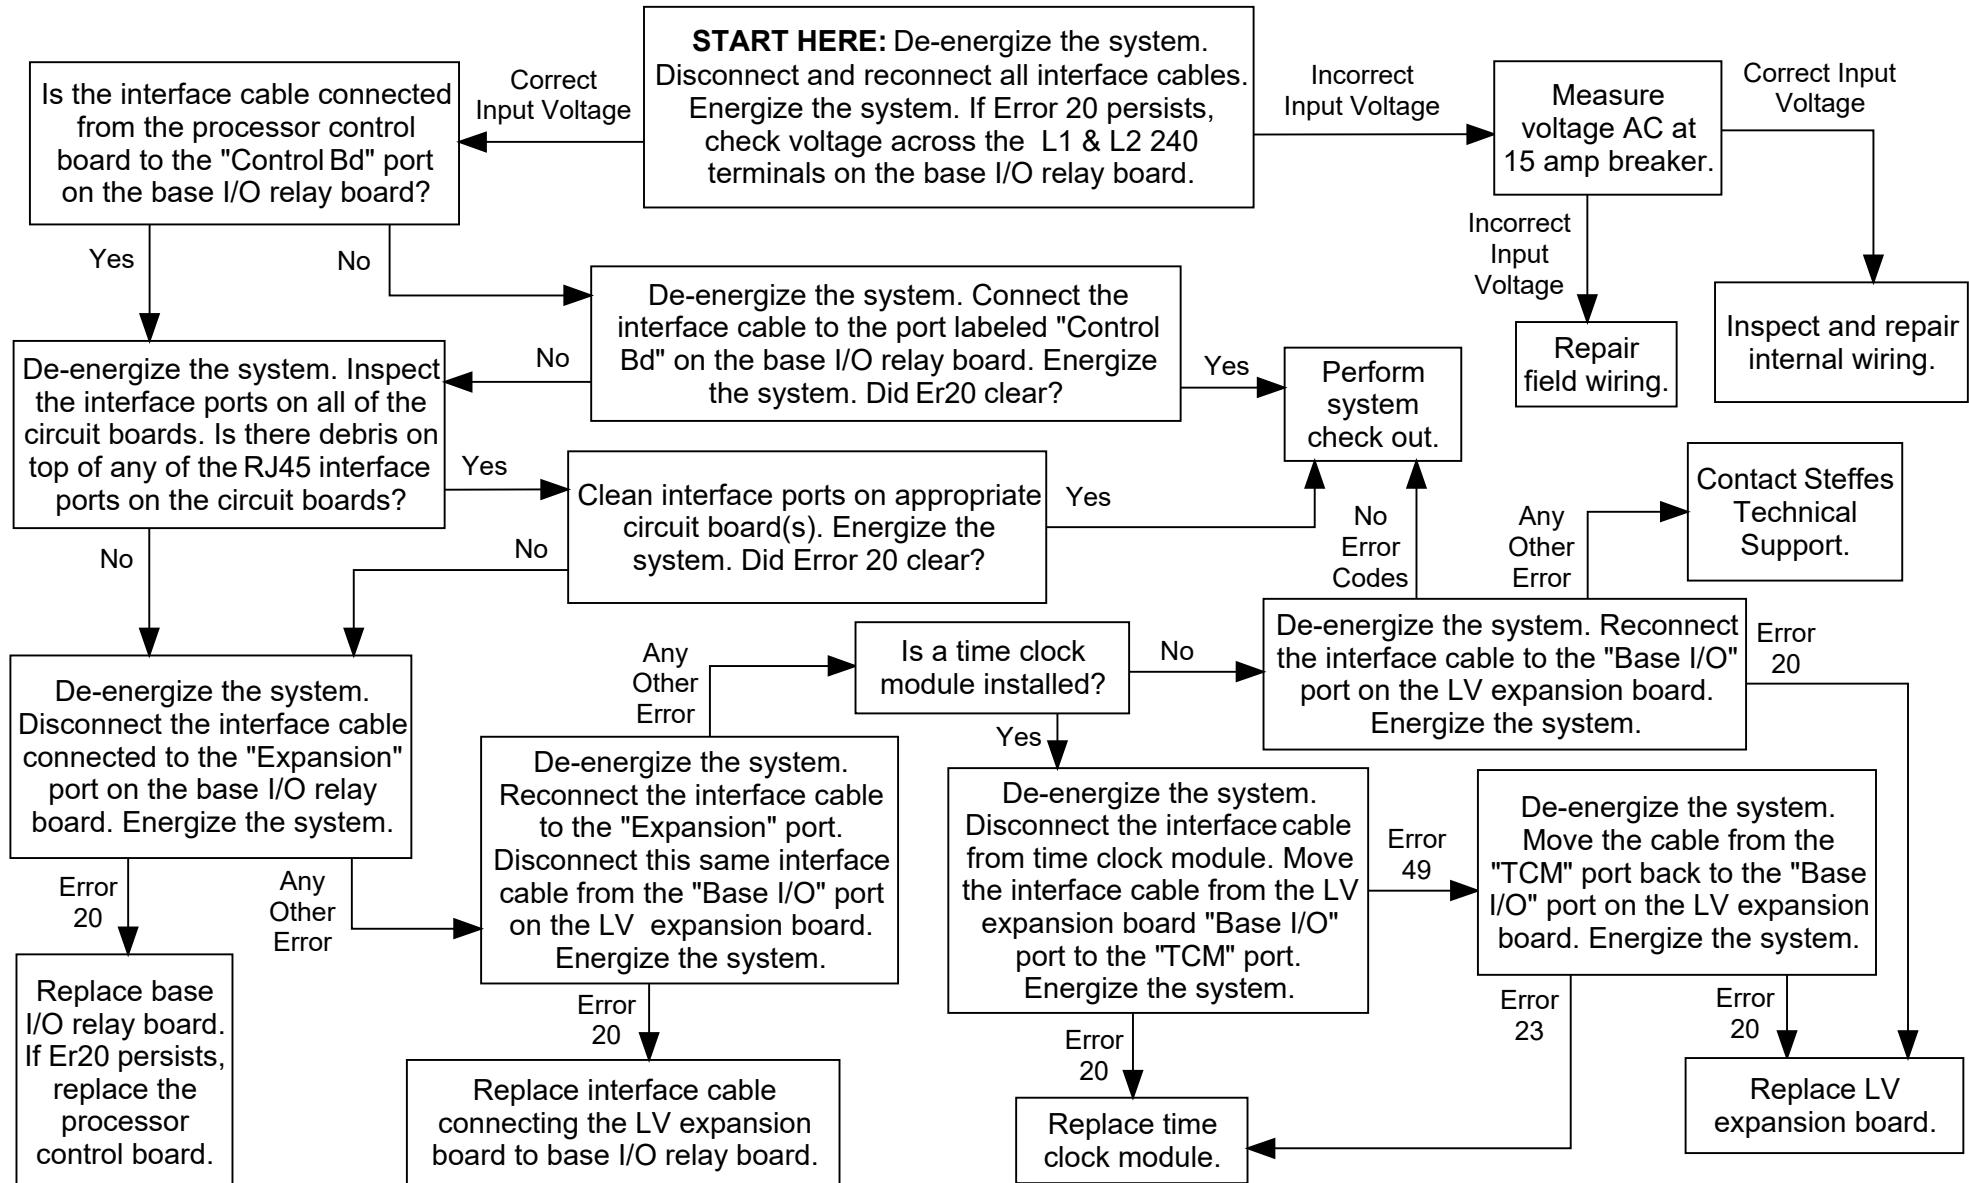
Error 20 occurs when there is a loss of communication from one circuit board to another. This may be caused by a loose connection of one of the interface cables, a defective interface cable, or a non-responsive circuit board. When troubleshooting, it is best to de-energize the Steffes heating system, disconnect and reconnect interface cables from the circuit boards one at a time, and then energize the heating system again. This will clear the Error 20 message if a loose connection was the cause. If the error message persists, examine the interface ports on each of the circuit boards for damage, corrosion, or debris. Verify the cable from the base I/O relay board is in the left port (Base I/O) on the LV expansion board. The time clock module, if installed, should be connected to the right port (TCM).
